Contract #: 04-0120F4Cty: SF/ALA Rte: 80 PM: 13.2/13.9File #: 1.28**WELDING INSPECTION REPORT****Resident Engineer:** Casey, William**Address:** 333 Burma Road**City:** Oakland, CA 94607**Report No:** WIR-029130**Date Inspected:** 11-Feb-2013**Project Name:** SAS Superstructure**OSM Arrival Time:** 700**Prime Contractor:** American Bridge/Fluor Enterprises, a JV**OSM Departure Time:** 1730**Contractor:** American Bridge/Fluor Enterprises, a JV**Location:** Job Site**CWI Name:** See below.**CWI Present:** Yes No**Inspected CWI report:** Yes No N/A**Rod Oven in Use:** Yes No N/A**Electrode to specification:** Yes No N/A**Weld Procedures Followed:** Yes No N/A**Qualified Welders:** Yes No N/A**Verified Joint Fit-up:** Yes No N/A**Approved Drawings:** Yes No N/A**Approved WPS:** Yes No N/A**Delayed / Cancelled:** Yes No N/A**Bridge No:** 34-0006**Component:** Tower**Summary of Items Observed:**

WELDING INSPECTION REPORT

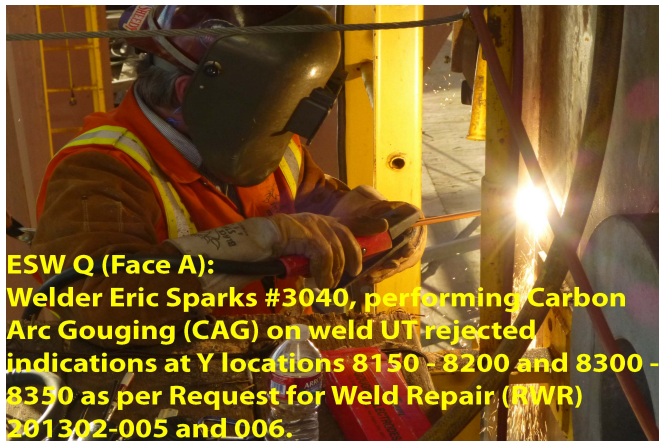
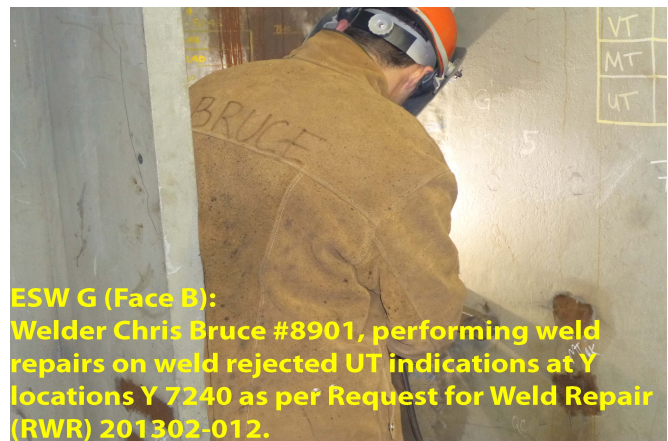
The welder was observed excavating by Carbon Arc Gouging (CAG) and performing the weld repair on the Electroslag Weld "G" at face B. The excavation was at Y location 7240 as per Request for Weld Repair (RWR) 201302-012 in way of an Ultrasonic Testing rejected indication. The welder was observed preheating the weld to 300 degrees Fahrenheit prior to welding using the Miller ProHeat 35 with heat induction blankets. The welder utilized the Welding Procedure Specification (WPS) ABF-WPS-D15-1000-Repair Rev.3 for Shield Metal Arc Welding (SMAW). The welding parameters were verified by QC Inspector William Sherwood throughout the day and appeared to be in compliance with the WPS noted above.

The welder was observed performing Carbon Arc Gouging (CAG) excavation and weld repairs on Electroslag weld "Q" at face A. The excavation and repairs were at Y locations 8150 - 8200 and 8300 - 8350 as per Request for Weld Repair (RWR) 201302-005 and 006 in way of Ultrasonic Testing rejected indications. The welder was observed preheating the weld to 300 degrees Fahrenheit prior to excavating and welding using the Miller ProHeat 35 with heat induction blankets. The welder utilized the Welding Procedure Specification (WPS) ABF-WPS-D15-1000-Repair Rev.3 for Shield Metal Arc Welding (SMAW). The welding parameters were verified by QC Inspector William Sherwood throughout the day and appeared to be in compliance with the WPS
